WELL-INTEGRITY SURVEY (PHASE II) OF ABANDONED HOMESTEAD WATER WELLS IN THE HIGH PLAINS AQUIFER, FORMER PANTECH ORDNANCE PLANT AND TEXAS TECH RESEARCH FARM NEAR AMARILLO, TEXAS, 1995

U.S. GEOLOGICAL SURVEY
Open-File Report 95-751

Prepared in cooperation with the
U.S. ARMY CORPS OF ENGINEERS,
TULSA DISTRICT

By Glenn A. Rivers

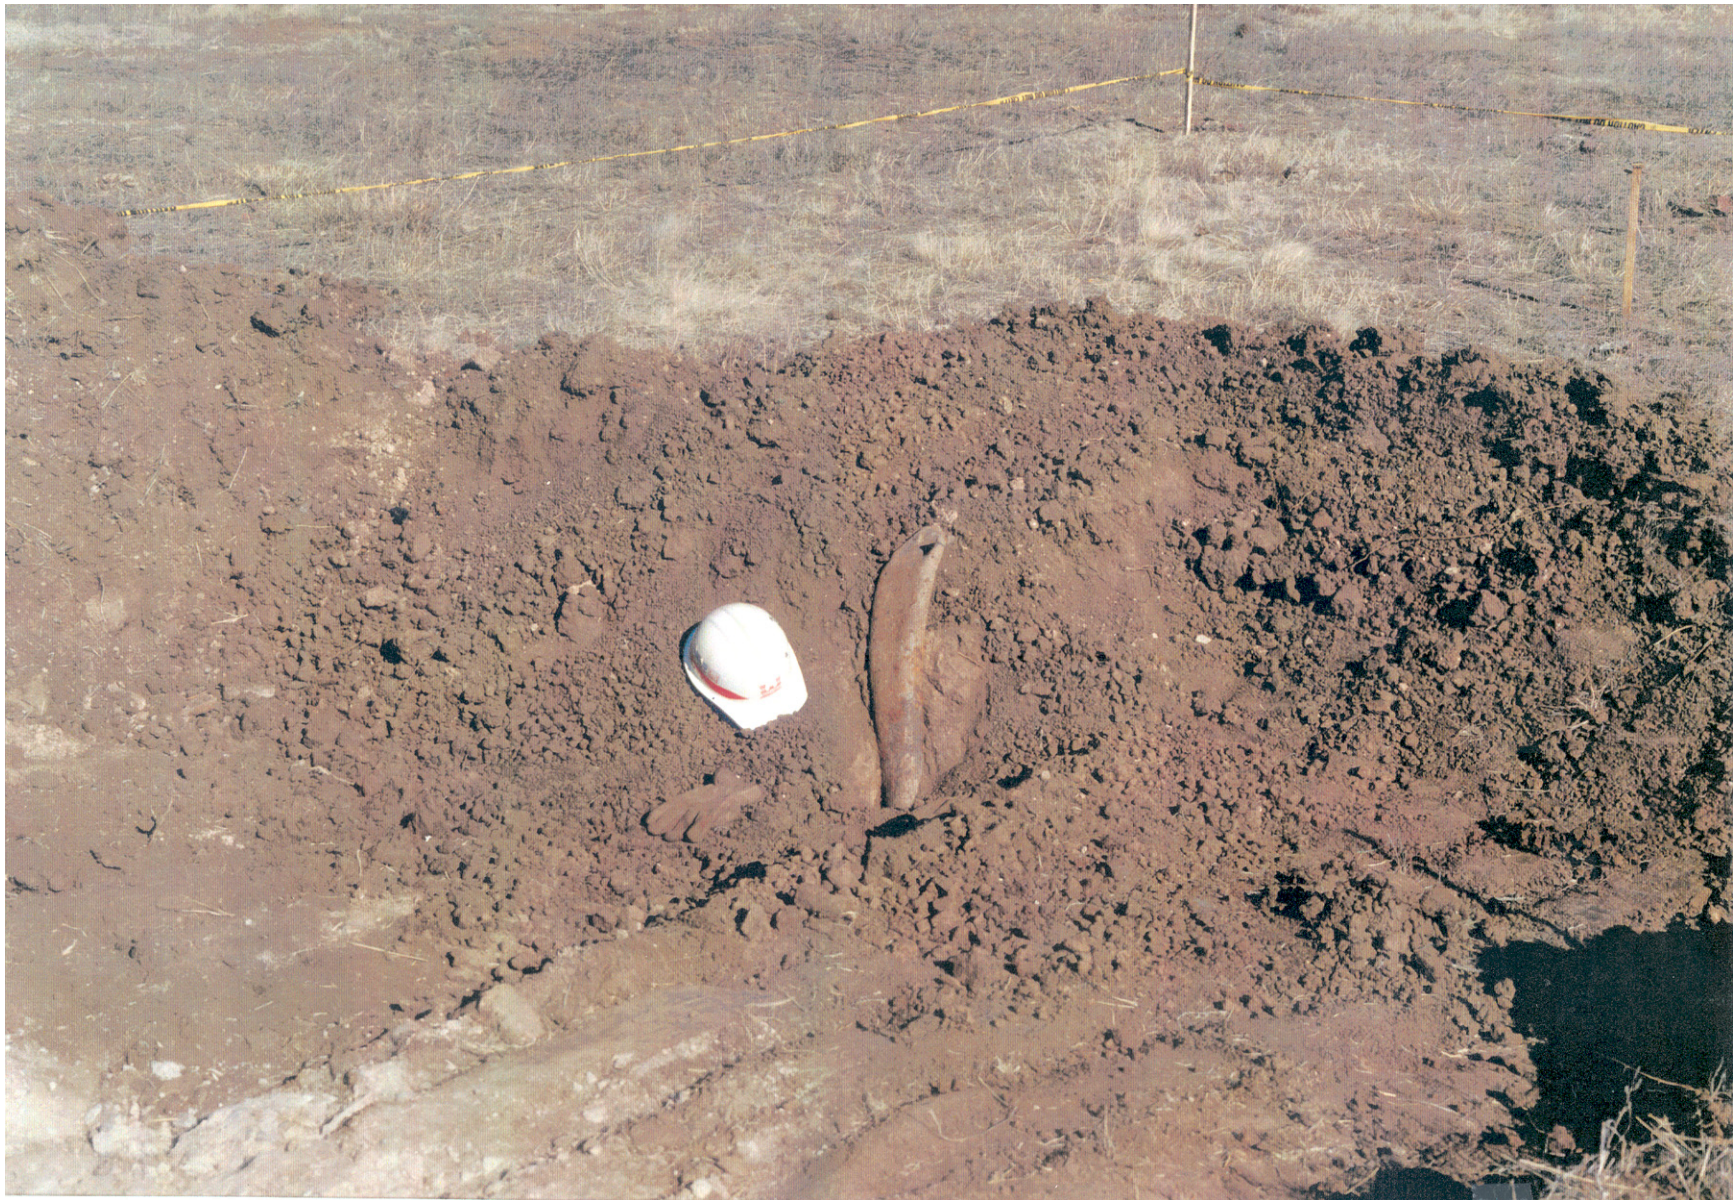
Figure 13. Excavated well casing at homestead site HL-5, former Pantex Ordnance Plant and Texas Tech Research Farm near Amarillo, Texas. Photograph by John S. Ebling.

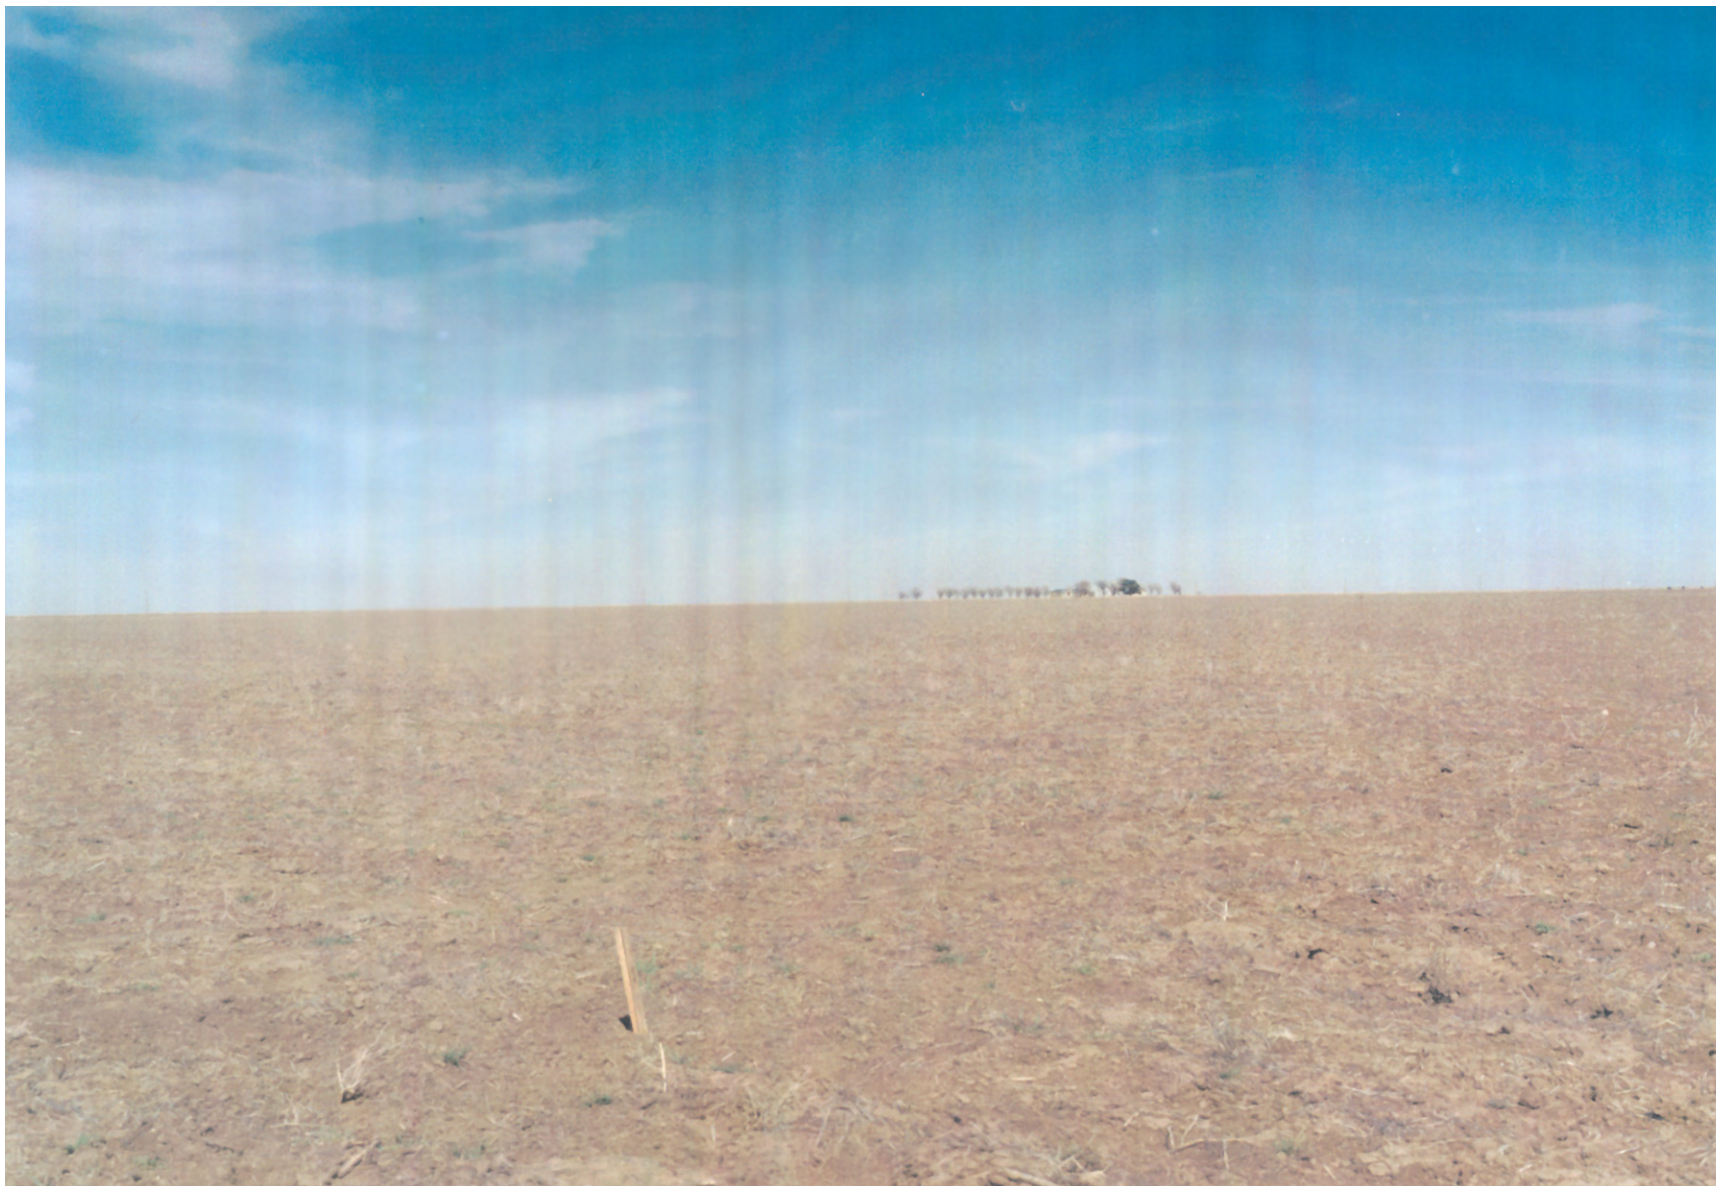
Figure 14. Homestead site HL-1, former Pantex Ordnance Plant and Texas Tech Research Farm near Amarillo, Texas. Photograph by John S. Ebling.

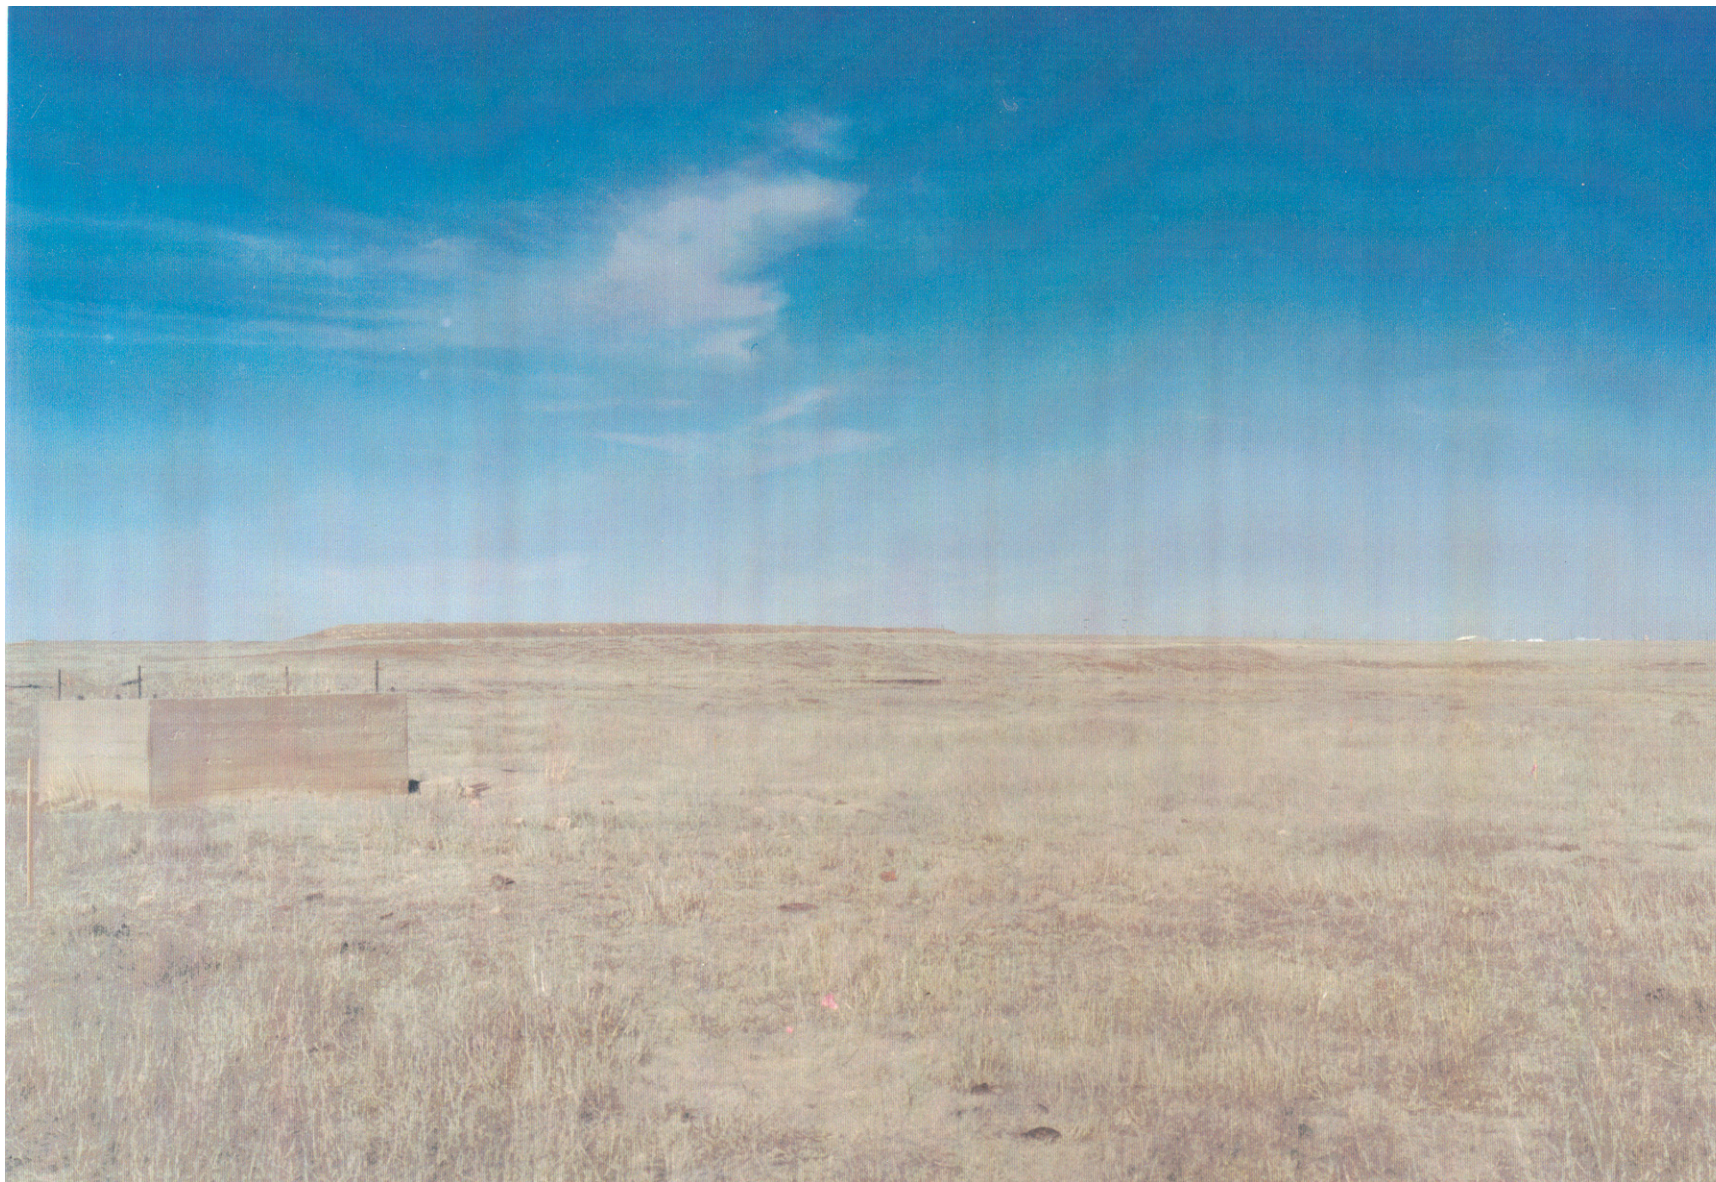
Figure 15. Homestead site HL-12, former Pantex Ordnance Plant and Texas Tech Research Farm near Amarillo, Texas. Photograph by John S. Ebling.

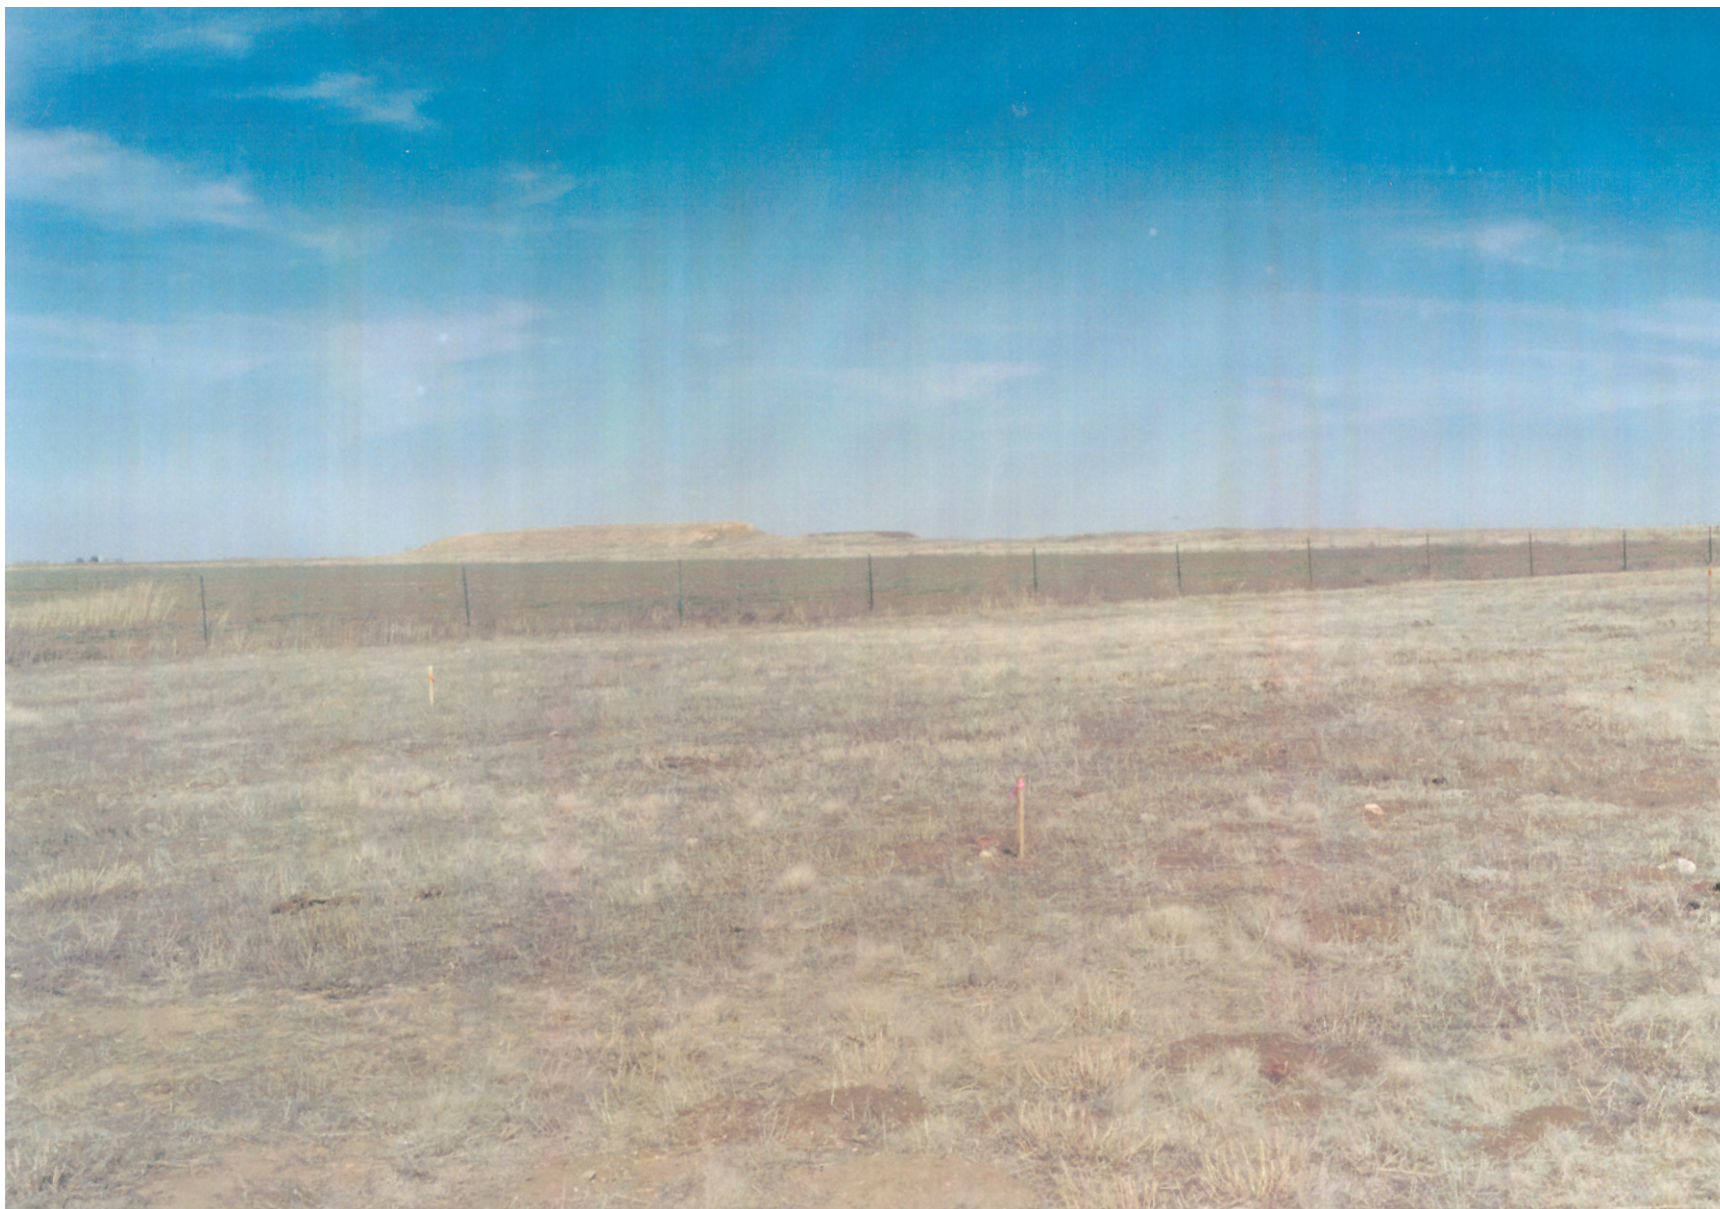
Figure 2-2. Homestead site HL-5 before excavation, former Pantex Ordnance Plant and Texas Tech Research Farm near Amarillo, Texas. Photograph by John S. Ebling.

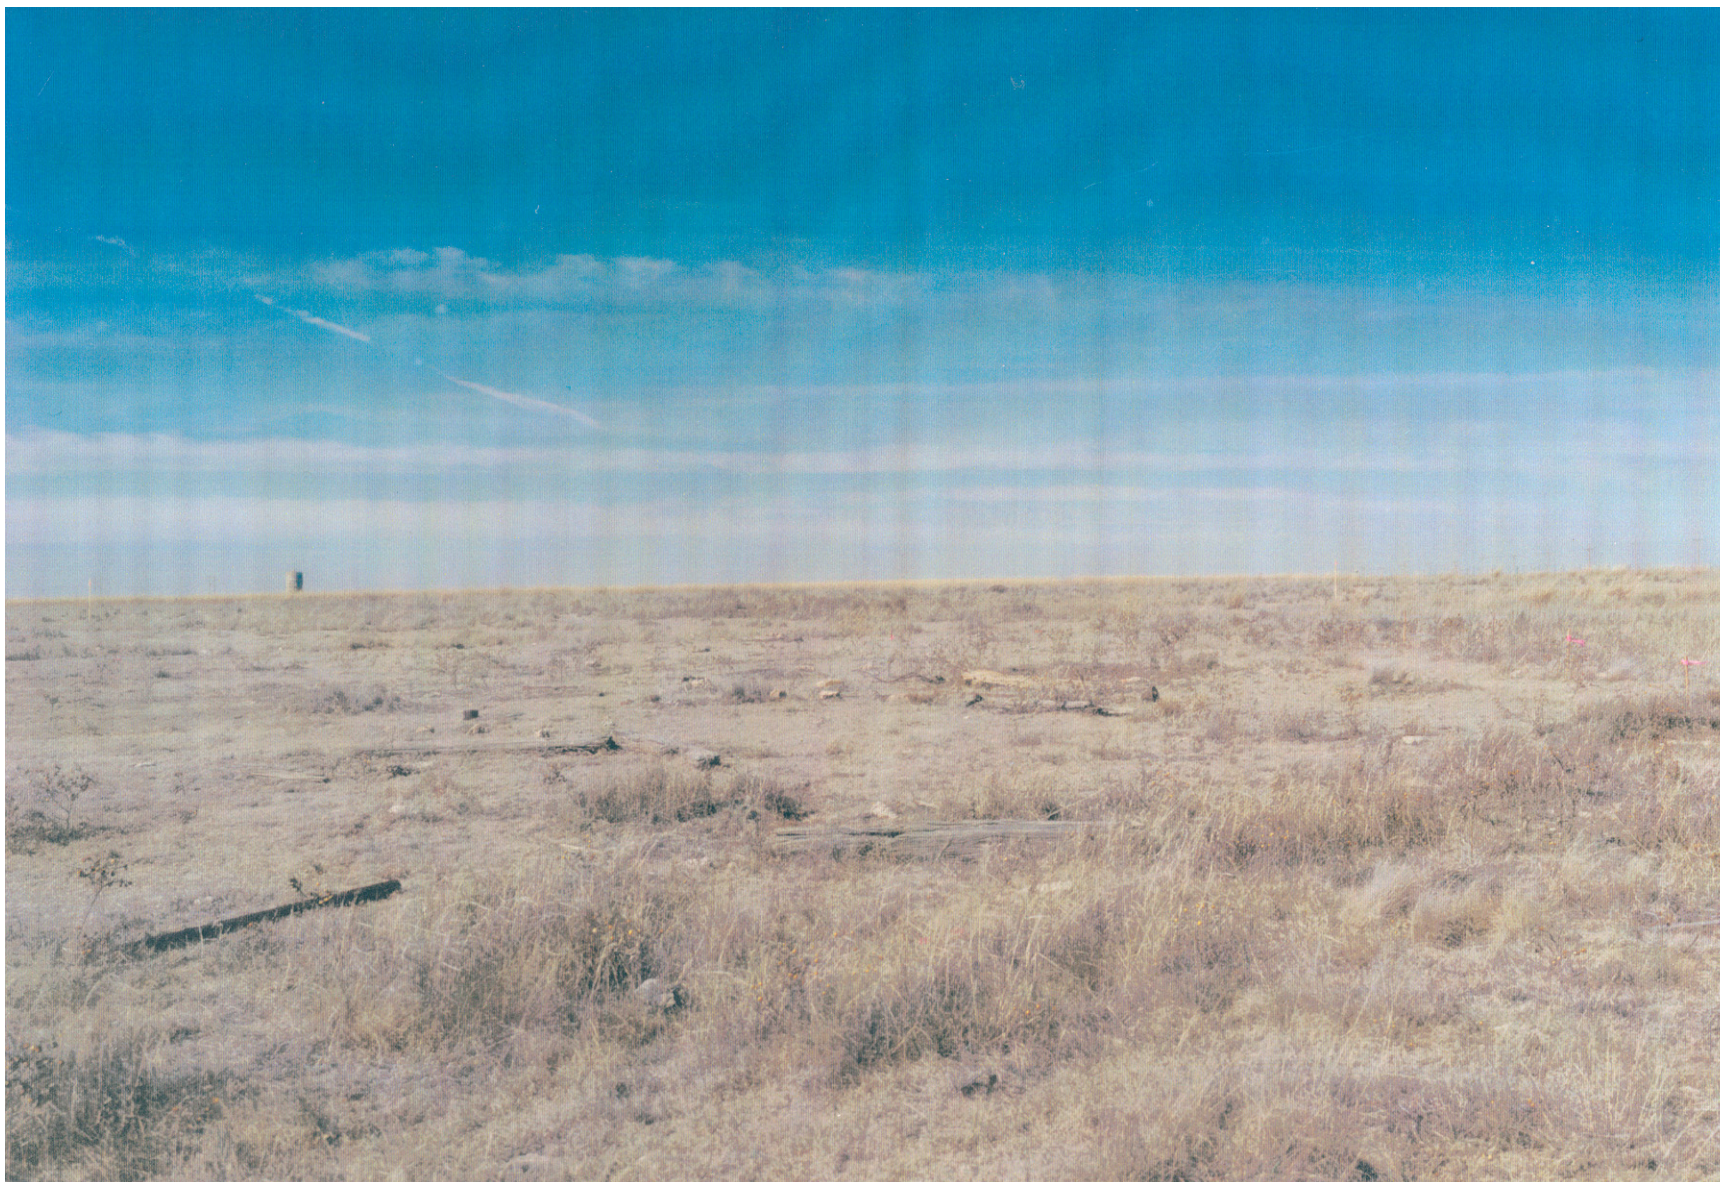
Figure 2-3. Homestead site HL-8 before excavation, former Pantex Ordnance Plant and Texas Tech Research Farm near Amarillo, Texas. Photograph by John S. Ebling.

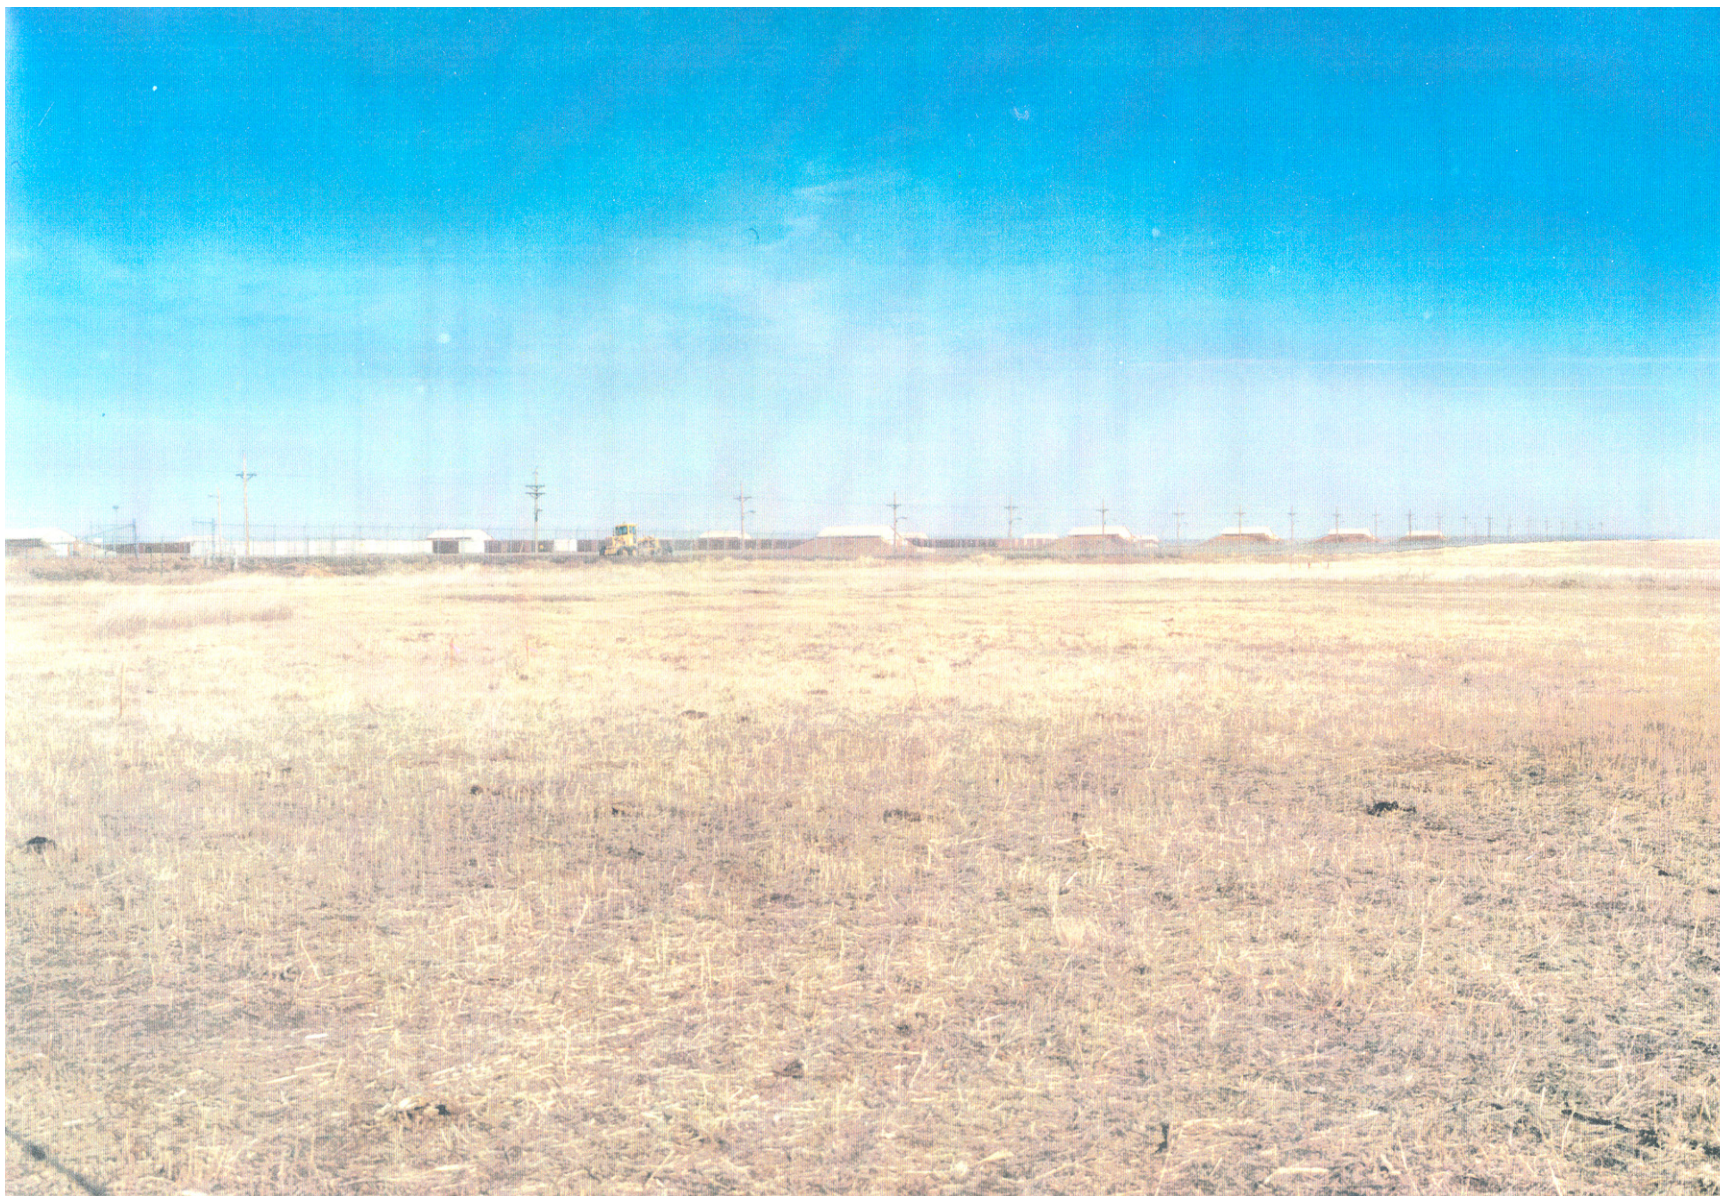
Figure 2-4. Homestead site HL-9 before excavation, former Pantex Ordnance Plant and Texas Tech Research Farm near Amarillo, Texas. Photograph by John S. Ebling.

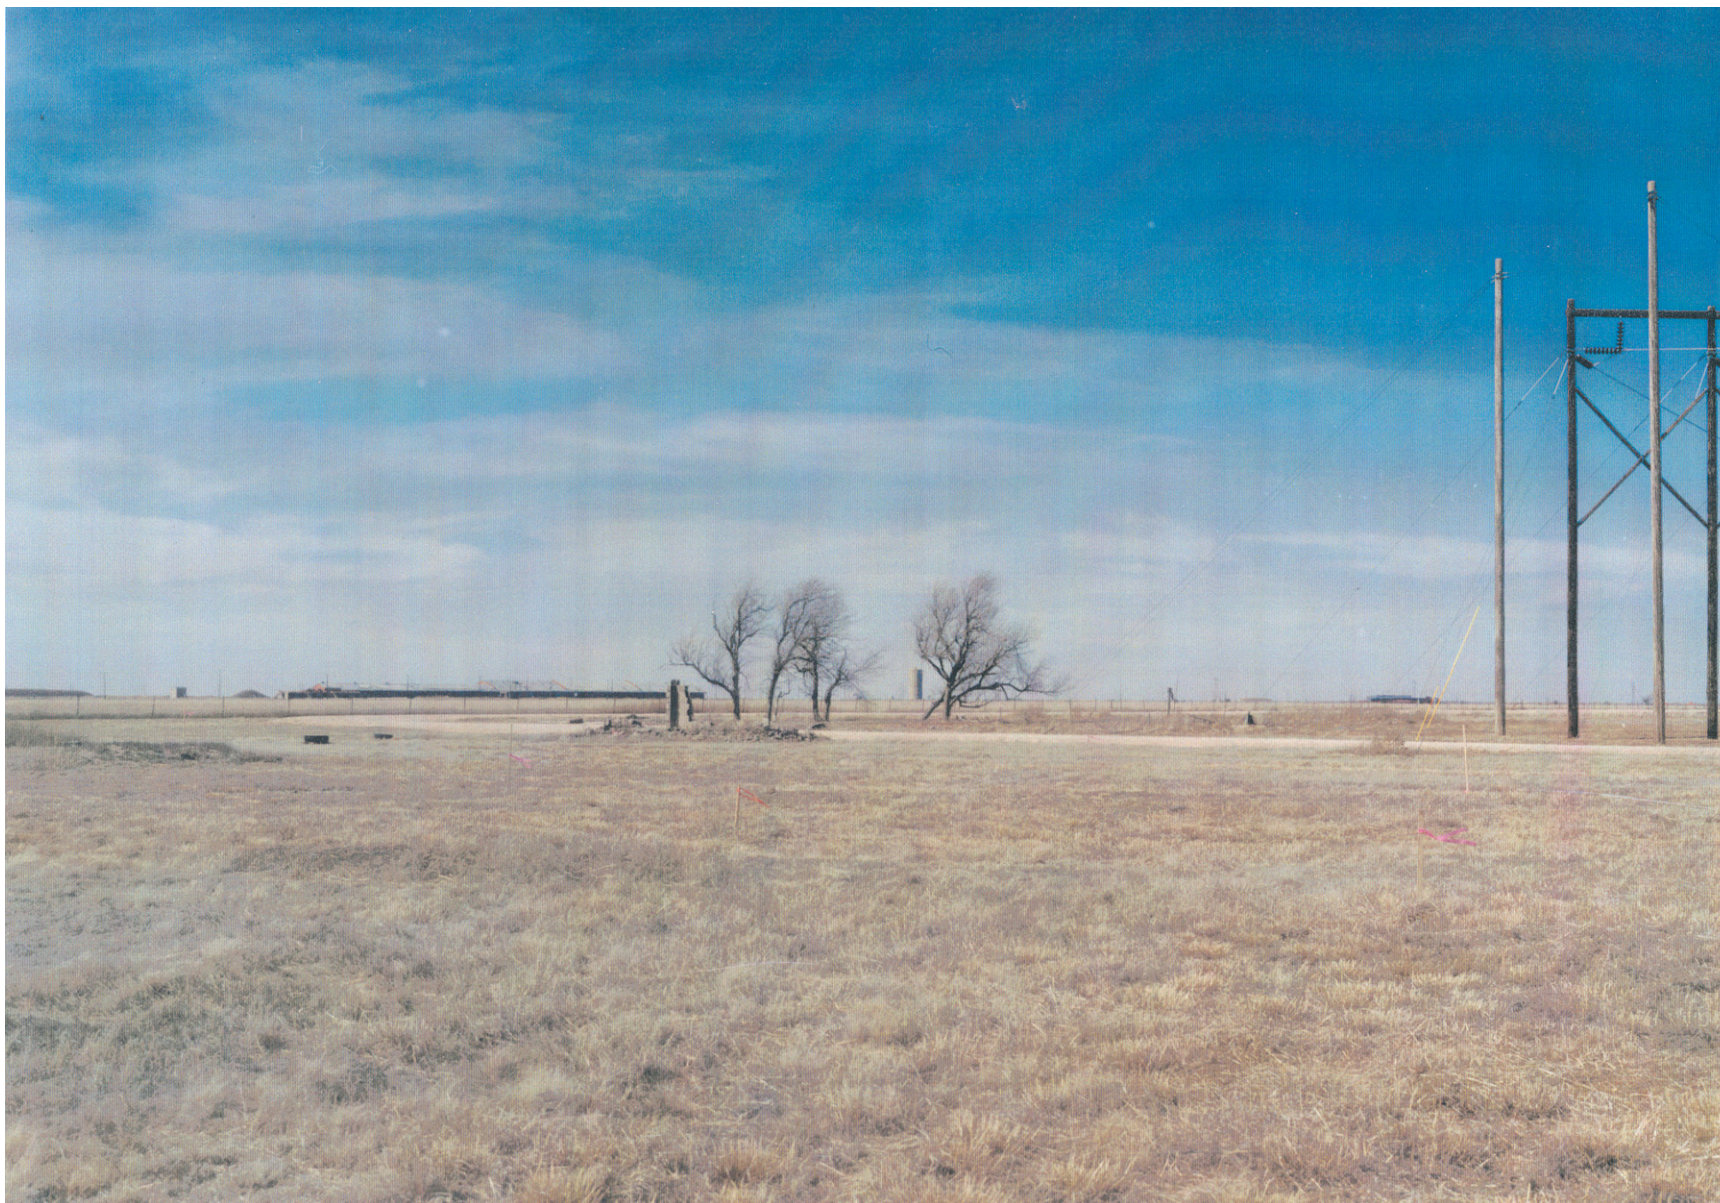
Figure 2-5. Homestead site HL-11 before excavation, former Pantex Ordnance Plant and Texas Tech Research Farm near Amarillo, Texas. Photograph by John S. Ebling.

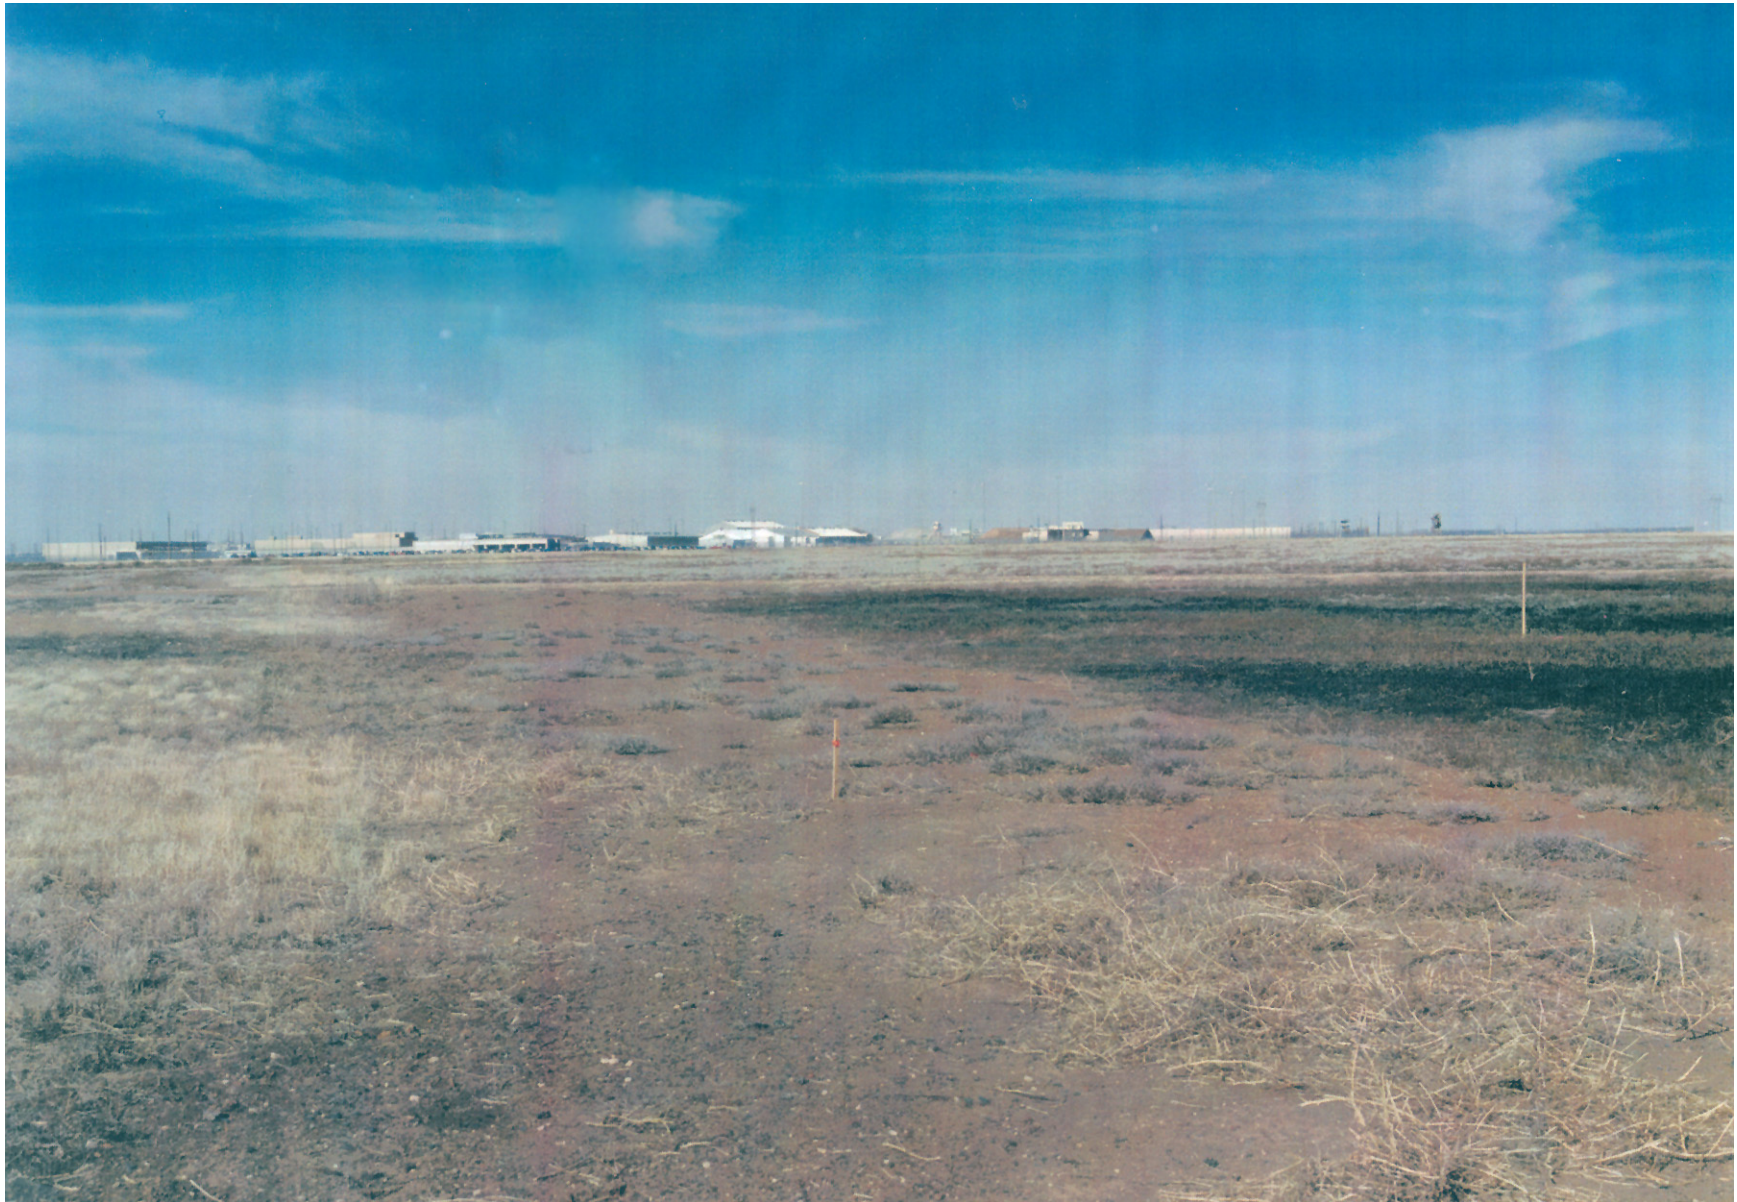
Figure 2-6. Homestead site HL-13 before excavation, former Pantex Ordnance Plant and Texas Tech Research Farm near Amarillo, Texas. Photograph by John S. Ebling.

(3) Evidence of past homestead existence was not found at 2 of the 18 locations: HL-6 and HL-13.

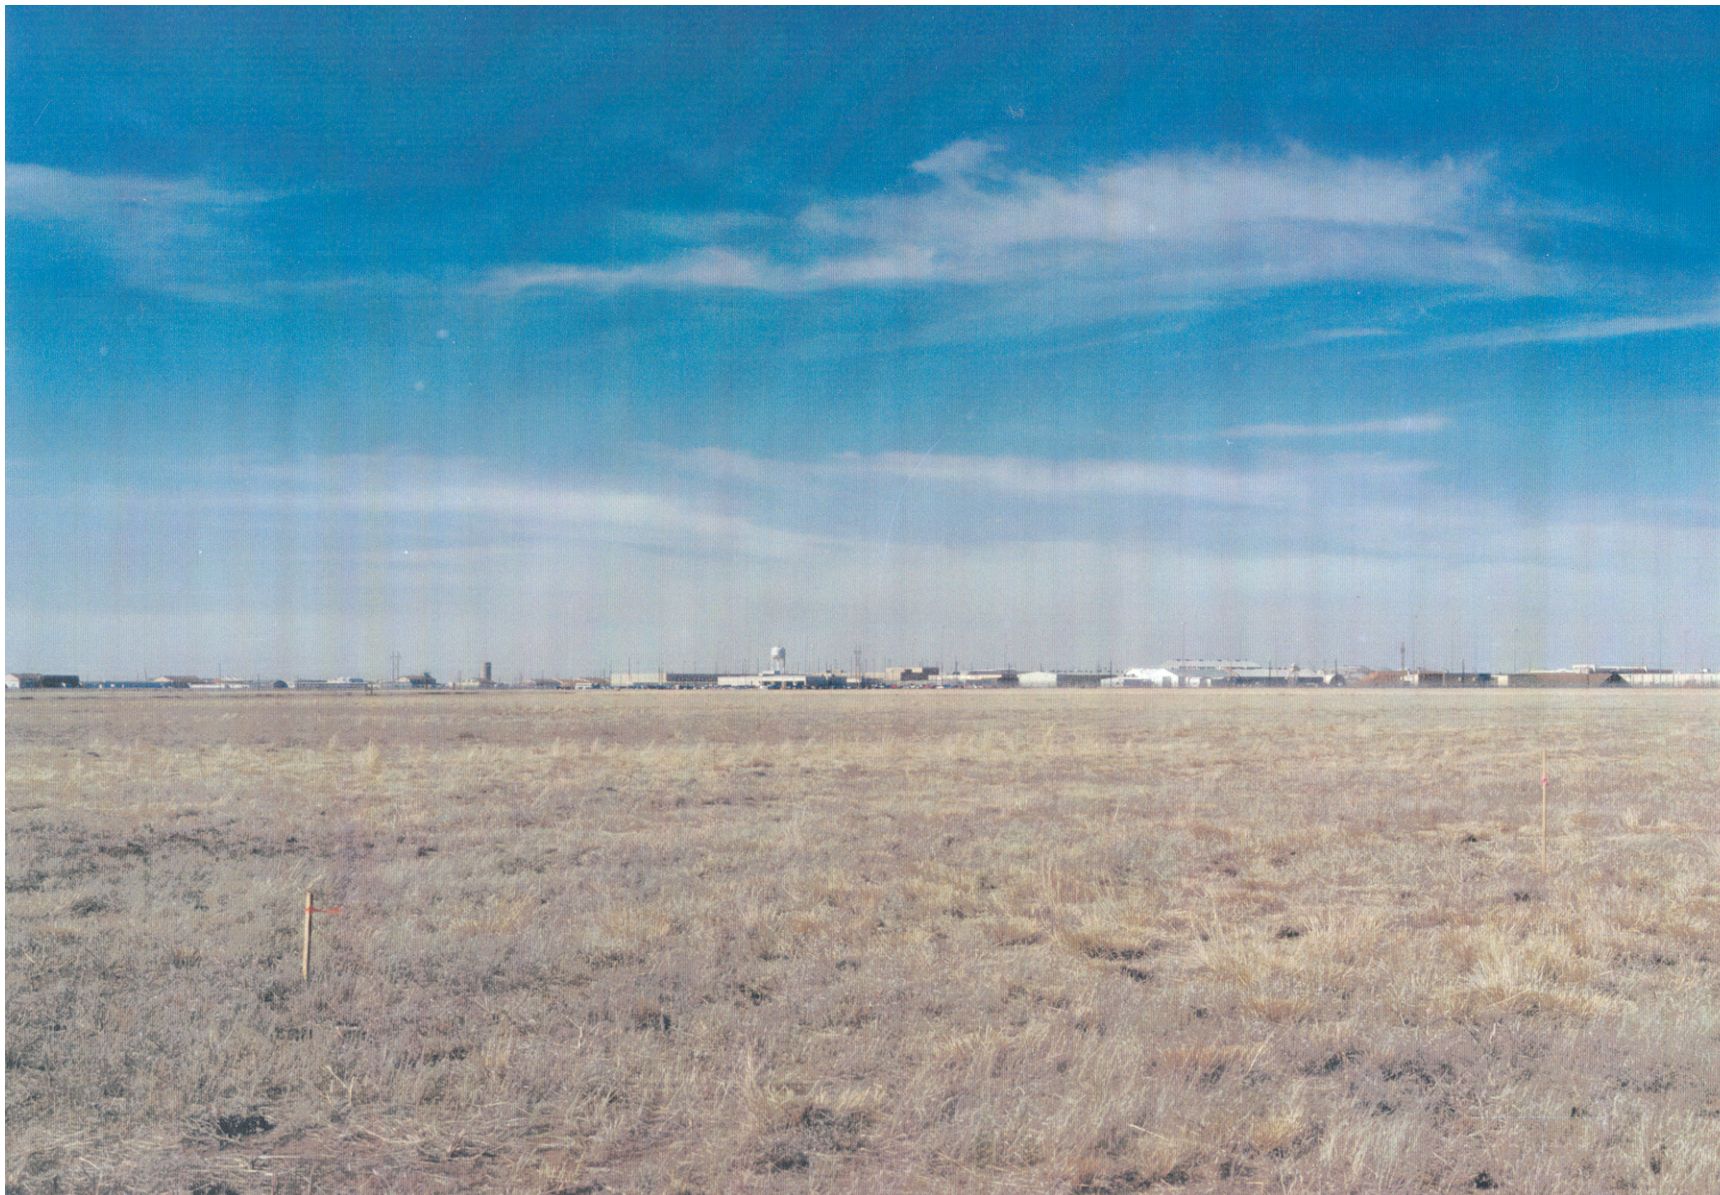
Figure 2-7. Homestead site HL-15 before excavation, former Pantex Ordnance Plant and Texas Tech Research Farm near Amarillo, Texas. Photograph by John S. Ebling.

(2) The existence of abandoned homestead sites was indicated only by broken glass and pottery and miscellaneous items (debris) at 3 of the 18 locations: HL-1, HL-7, and HL-15.

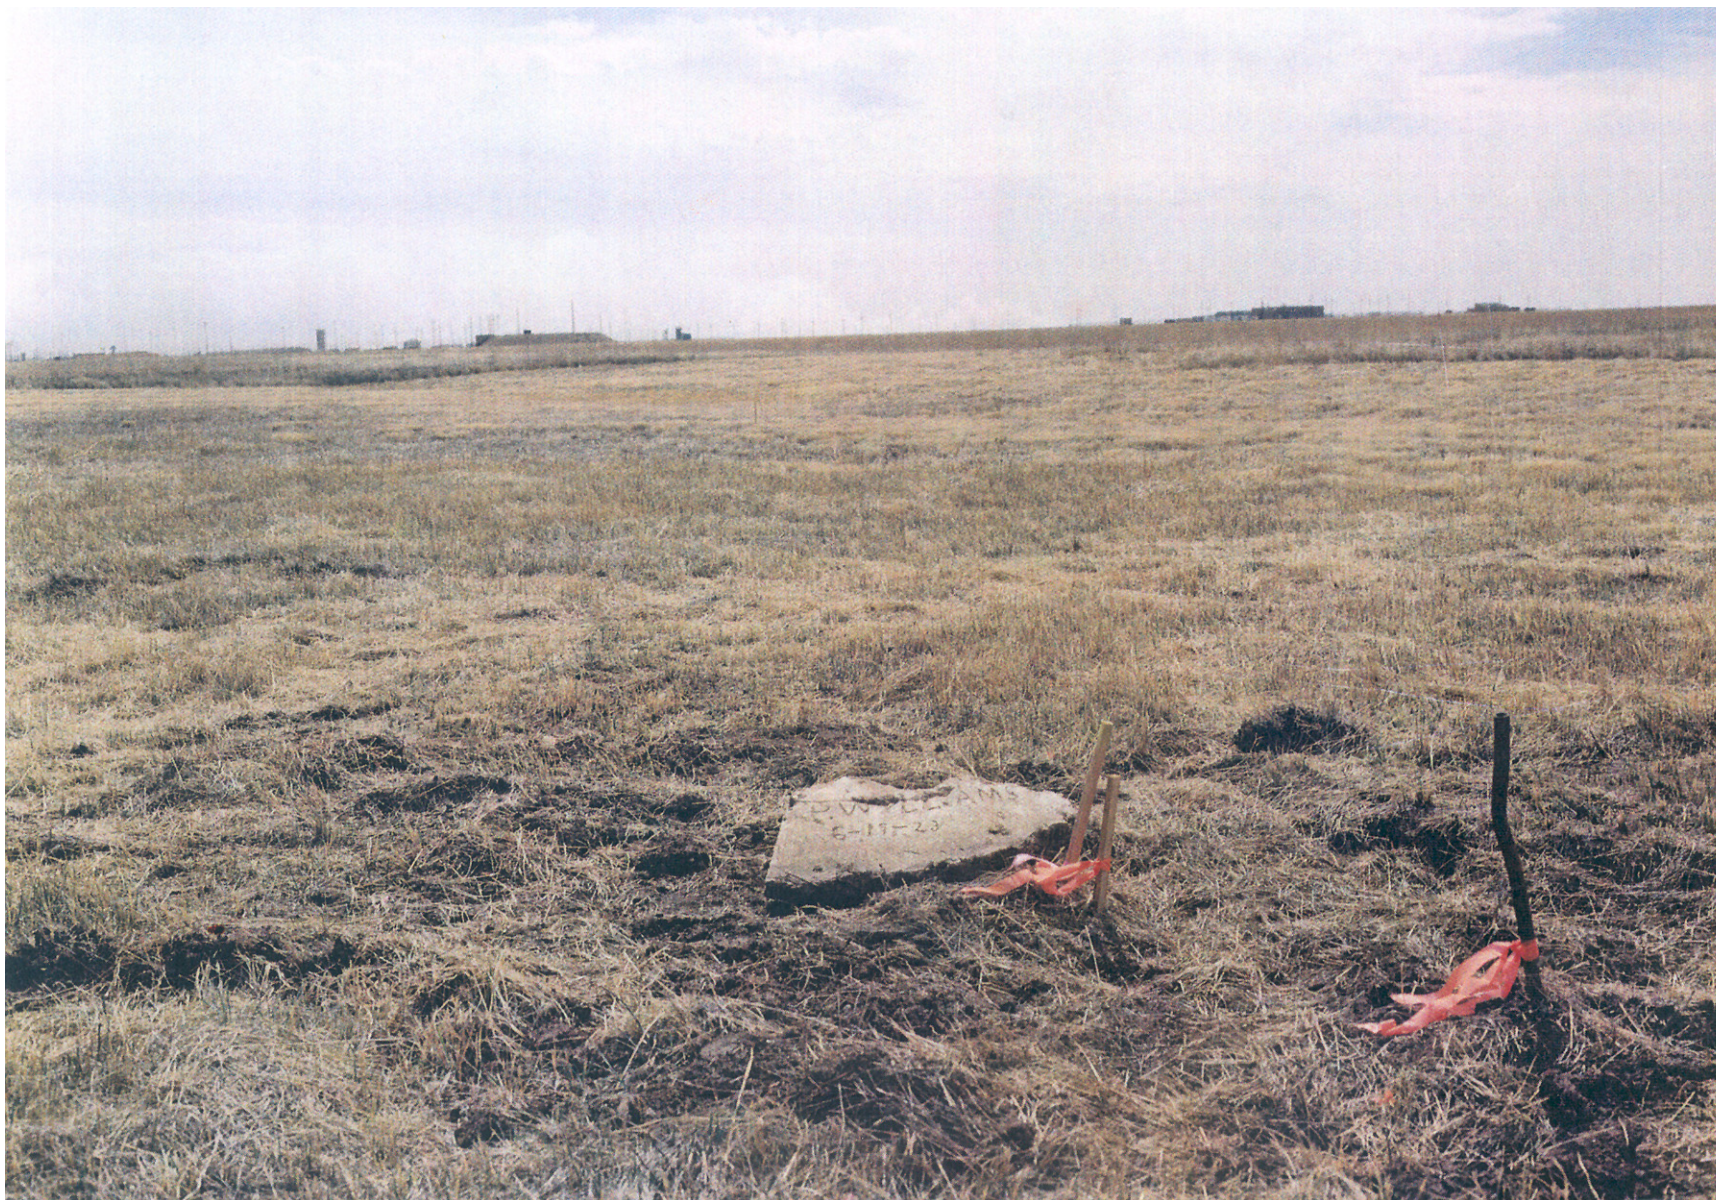
Figure 3-1. Homestead site HL-3 after excavation, former Pantex Ordnance Plant and Texas Tech Research Farm near Amarillo, Texas. Photograph by John S. Ebling.

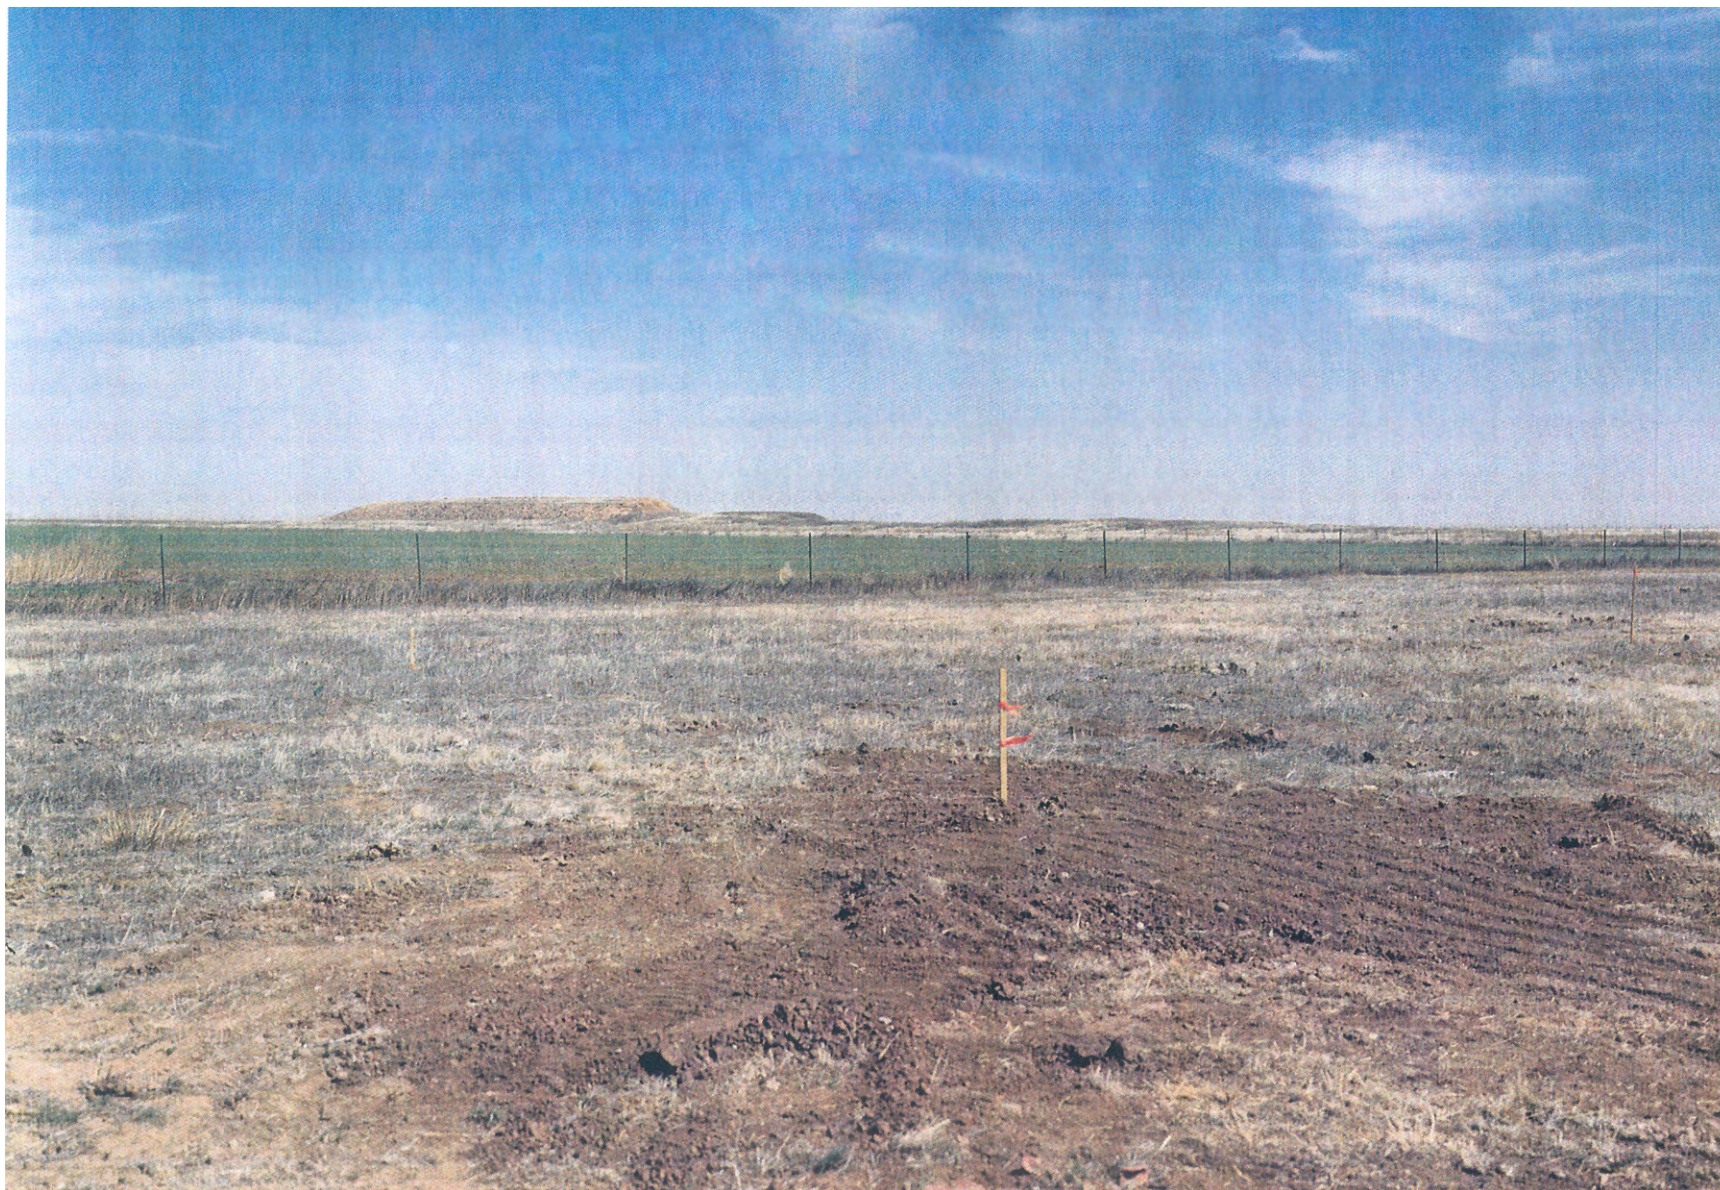
Figure 3-2. Homestead site HL-5 after excavation, former Pantex Ordnance Plant and Texas Tech Research Farm near Amarillo, Texas. Photograph by John S. Ebling.
